## Hardwood Troubleshooting

## NOFMA TIP SHEET

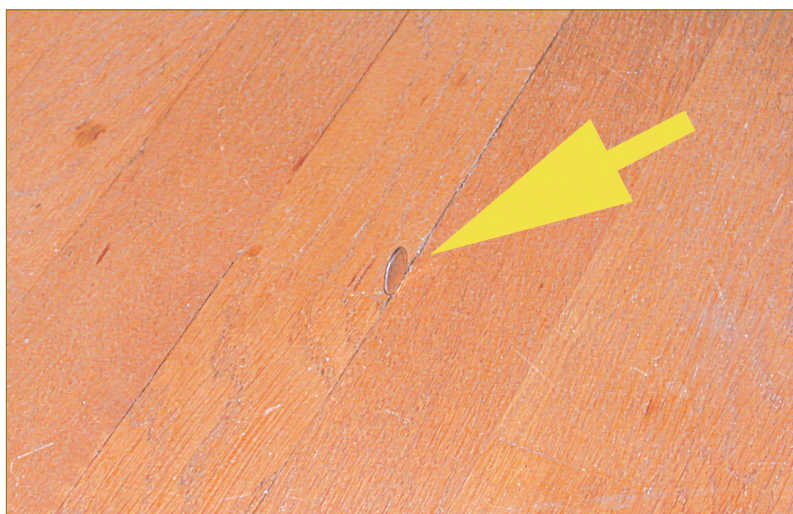
**This nickel-sized gap closes seasonally; this is a normal gap.**

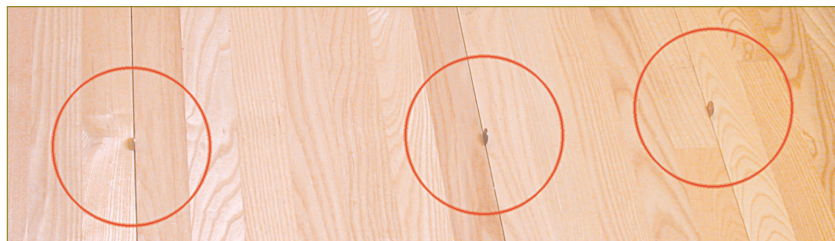
Quarter-sized gaps showing panelizing; most close seasonally.

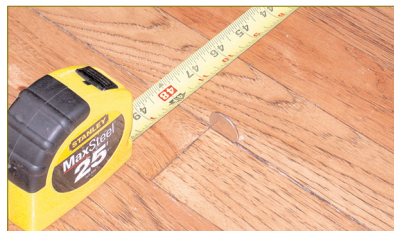
This floor was oversized by 3/4-inch at the time of installation; there are 21 runs in 48 inches; nominal measure is 47 1/4 inches.

resulting in permanent gaps.

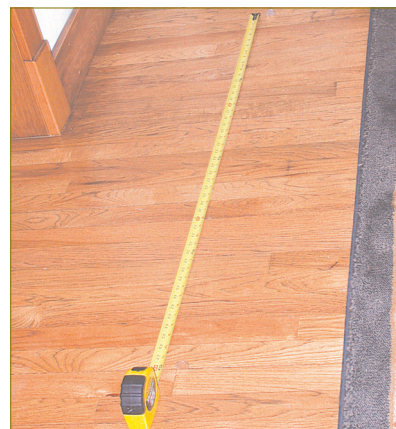
Wider gaps at 0 inches and 48 inches, due to higher subfloor moisture content at installation.

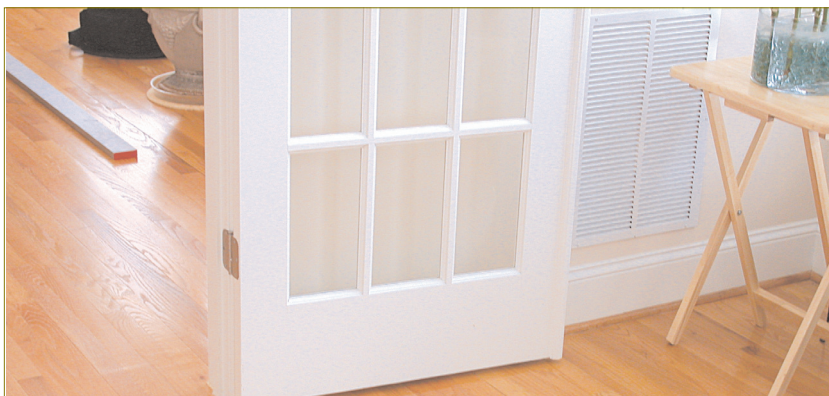
**Note gap under door and near straight edge. There is a gap in both rooms along the subfloor panel edge.**

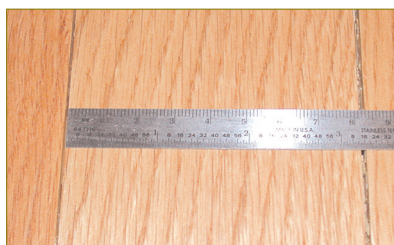
**3 1/4-inch Strip 3/64-inch undersize, less than 6 percent present moisture content, manufactured less than 9 1/2 - 10 percent moisture content, within the NOFMA specification standards.**
